Product Safety Recall

450R & 500R V8 Racing Outboard Top Cowl Bezel Assy

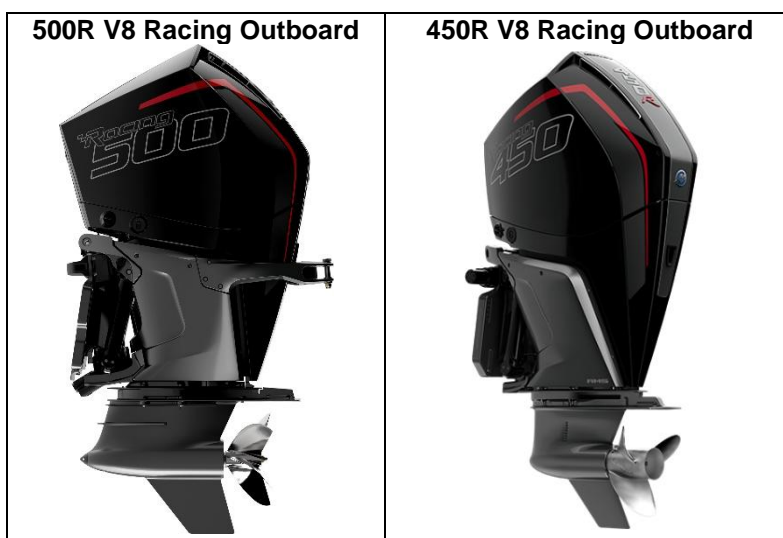
Identification Pictures

Defect: The air vents of the affected engine cover may allow for fingers to be placed through the air vent gaps.

Hazard: There is a risk of serious injury including amputation or lacerations to fingers if placed through the air vents. Injuries have occurred because of this hazard.

1. Consumers with affected products should contact their Mercury dealer to arrange for a bezel assembly to be installed over the air vents.
2. Send us an email or phone us if you are unable to return the product or have sold or gifted it to another person
