Product Safety Recall

V6, V8 and V8R Outboards Top Cowl Assembly

Models Covered	Serial Range
V8 200–300 and V6 175–225 FourStroke, Pro XS®, SeaPro™, and Verado® Models	V8 2B529482 – 3B430915
	V6 2B529482 - 3B421321
V8 250R, V8 300R and 300R HD Models	1E080500 - 1E091195
	2B529482 – 3B430915

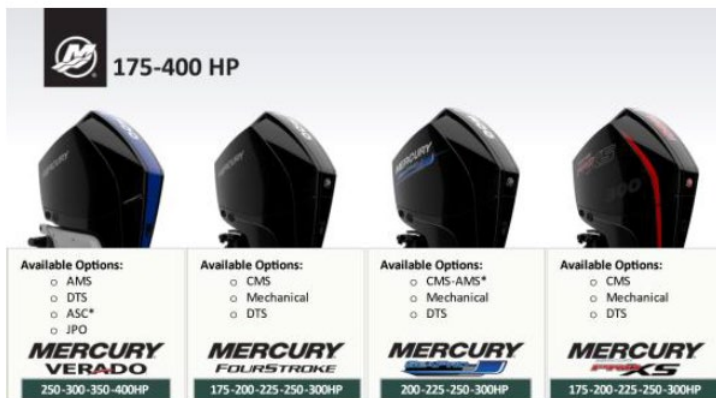
Defect: The air vents of the affected engine cover may allow for fingers to be placed through the air vent gaps.

Hazard: There is a risk of serious injury including amputation or lacerations to fingers if placed through the air vents. Injuries have occurred because of this hazard.

1. Always keep fingers away from the air vents on the engine. Do not use the air vents as a handhold when boarding or departing the boat.
2. If your cowl does not have two silver coloured bezel assembly currently installed, please contact your local Mercury Marine Authorized Outboard Dealer to arrange for these to be fitted over the air vents. This will be done at no cost to you.
